CAFO FACILITY INSPECTION REPORT

Chino Valley Dairy
FACILITY NAME

03/07/2013
ACTUAL INSPECTION DATE

REPORT PREPARED BY: Anthony D'Angelo (PG Environmental, LLC) ON 03/21/2013

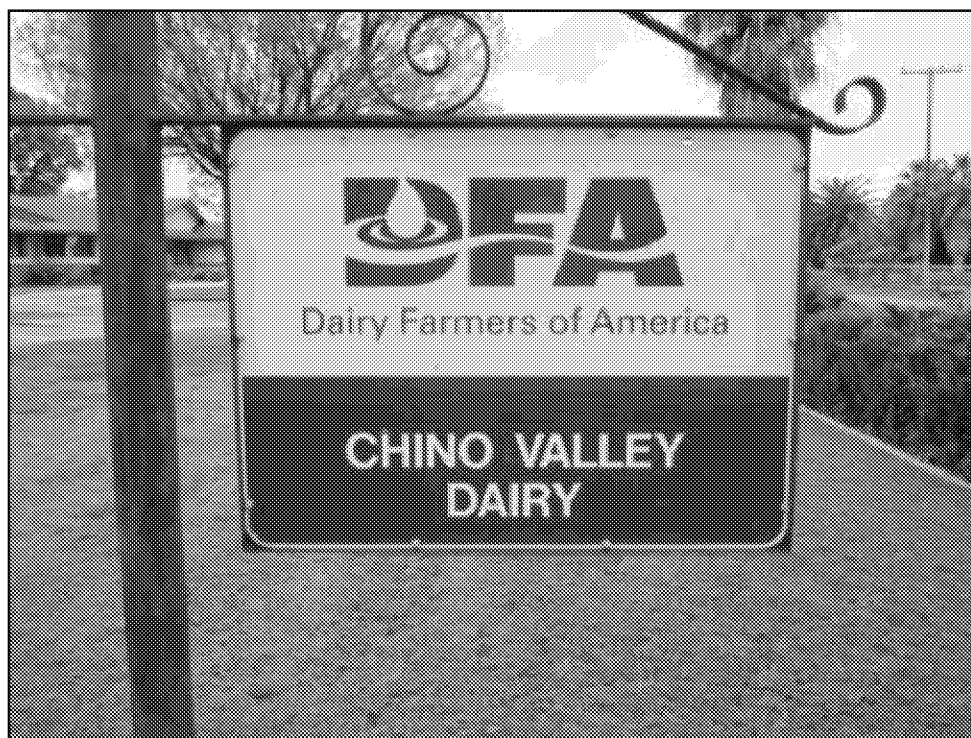
Photograph 1. Chino Valley Dairy Facility sign.

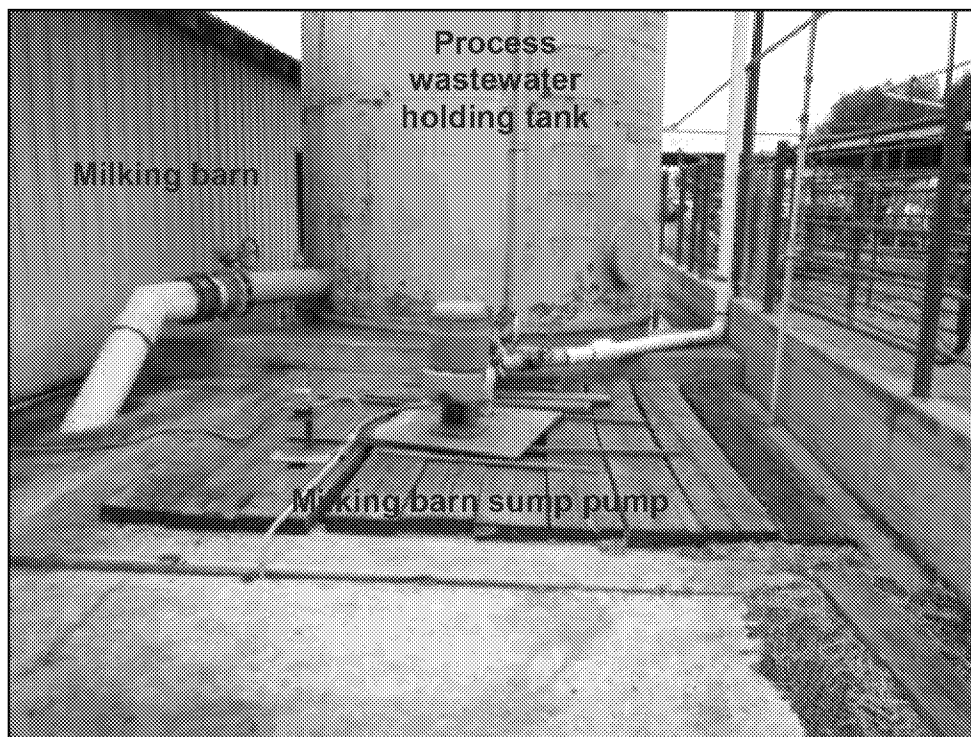
The Facility is a 78.8-acre dairy farm with an animal population of approximately 1,100 milking cows, 250 dry cows, and 200 heifers at the time of the inspection. Process wastewater from milking and cow washing activities is collected into a sump on the south side of the milking barn (refer to Photo 2). Process wastewater collected in the sump can be piped south to lagoon No. 1 located in the central portion of the Facility via gravity or pumped to field Nos. 1 or 2 for land application via approximately six (6) alfalfa heads (refer to Photos 4 through 10). Mr. Van Leeuwen stated that during the winter months, process wastewater from the milking barn is stored in an aboveground storage tank and used to flush the feed and hay lanes (refer to Photos 2, 3, and 14). Process wastewater from flushing activities is collected into floor drains on the south end of the feed lanes and is piped directly into lagoon No. 1 (refer to Photos 14 and 15). Field storm water runoff and excess process wastewater from land application events is collected in the southwest corner of the Facility, and may be pumped via a sump pump as return flow back into lagoon Nos. 1 and 2 (refer to Photo 7). A concrete spillway for emergency offsite discharges from catch basin No. 3 was identified in the southwest corner of the Facility, adjacent to Ex. 6 Personal Privacy (PP) (refer to Photo 17). Process wastewater collected in lagoon No. 2 located on the central-east portion of the Facility is released south through two (2) valves onto field No. 3 located in the southeast corner of the Facility for land application (refer to Photos 11 and 12). Surface runoff from corral Nos. 1 through 4 flows south then west into field No. 1. Surface runoff from the remainder of the corrals flows south into floor drains and culverts on the south side of the corrals, and subsequently piped directly into lagoon No. 1 (refer to Photos 13 through 16). Surface runoff from the pasture Nos. 1 through 5 naturally flows south and is collected into two sumps located in pasture No. 5 which drains to lagoon No. 2. At the time of the inspection, process wastewater from the milking barn was being pumped to the distribution manifold on the northside of field No. 1, conveyed along the land application line, and released out of an alfalfa valve immediately upgradient of lagoon No. 2 (refer to Photo 10). Lagoon No. 2 was observed containing standing water and had approximately three (3) feet of freeboard (refer to Photo 11). Mr. Van Leeuwen stated all process wastewater was being diverted to lagoon No. 2 because the Discharger was preparing to install an access ramp into lagoon No. 1 on the western embankment to allow access for cleaning. In addition, Mr. Van Leeuwen stated that lagoon No. 1 had not been cleaned of solids since the Discharger took operational control of the Facility in September 2010. Accumulated manure solids were observed in the lagoon (refer to Photos 4, 5, and 6).

Photograph 2. View facing east of the process wastewater sump pump and process wastewater holding tank on the south side of the milking barn. Note the holding tank is used to store process wastewater for cow alley flushing activities.

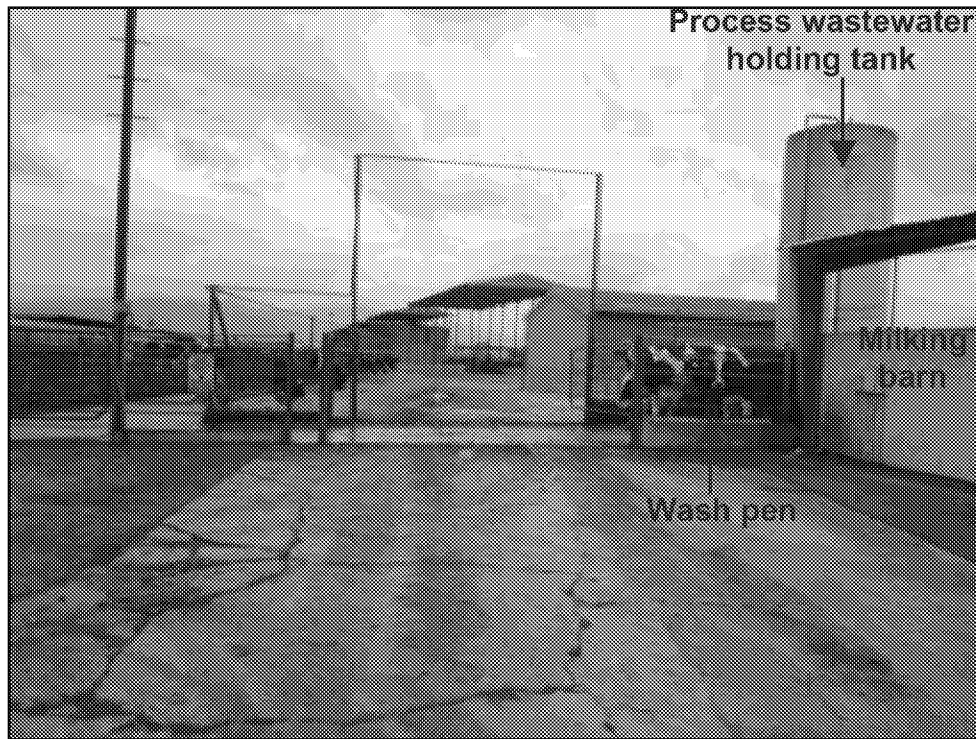
Photograph 3. View facing south from the east side of the milking barn down the western feed and hay lane. Note the holding tank used for storage of process wastewater during the winter months.

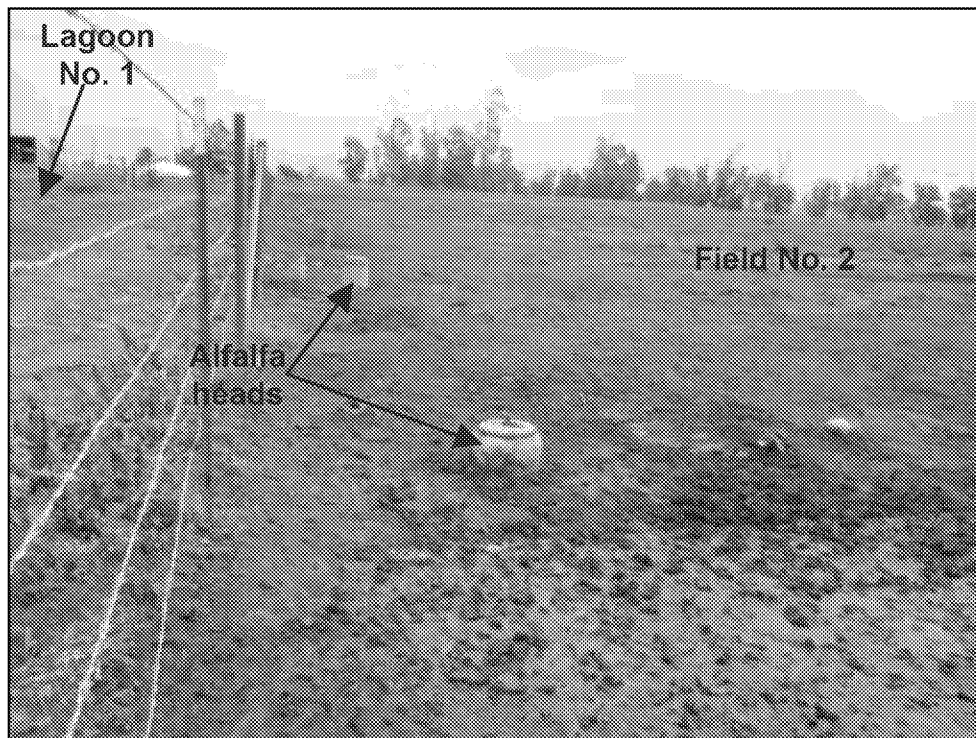
Photograph 8. View facing east of the alfalfa head disposal valves on the north side of field No. 2, adjacent to lagoon No. 1.

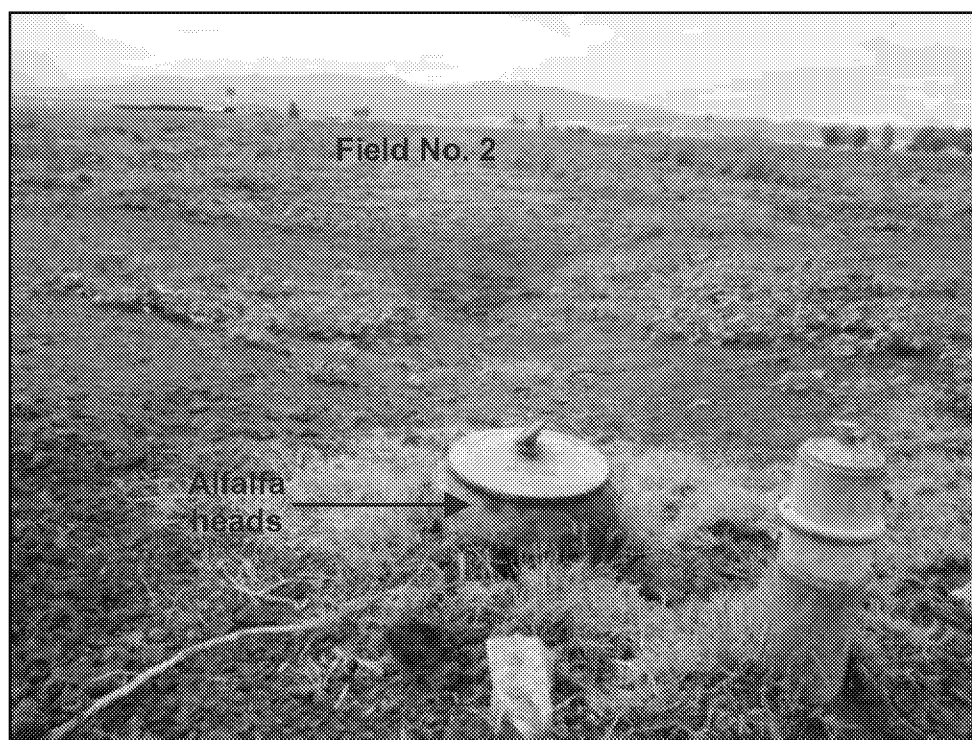
Photograph 9. View facing south of an alfalfa head disposal valve on the north side of field No. 2.

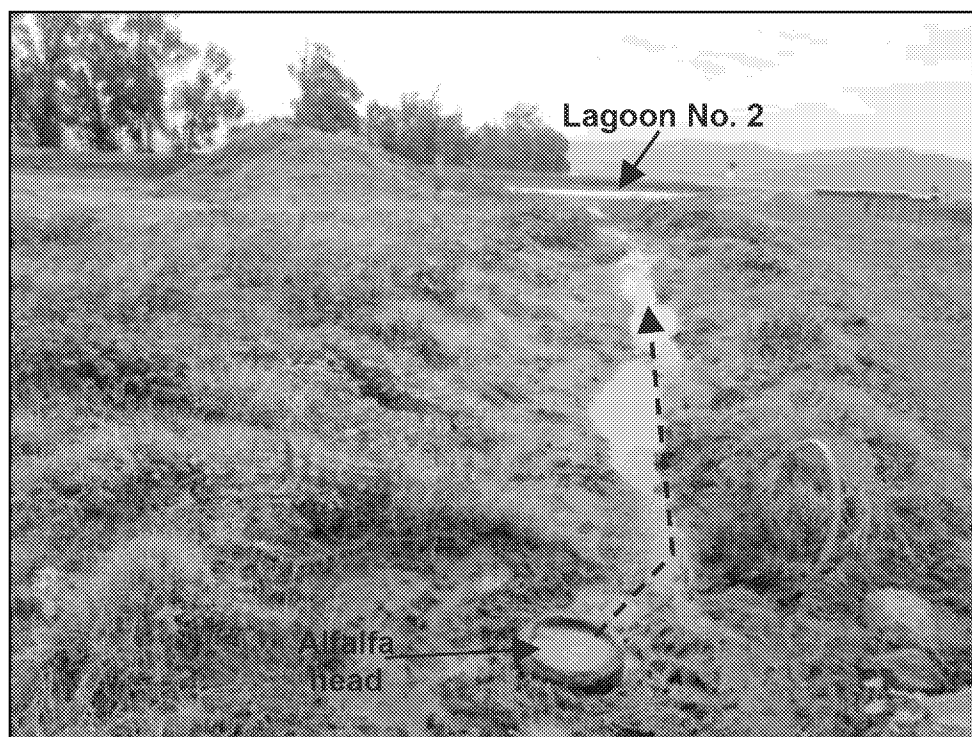
Photograph 10. View facing south of an alfalfa head disposal valve releasing process wastewater into lagoon No. 2. Note the collected water in lagoon No. 2 is used to irrigate field No. 3.

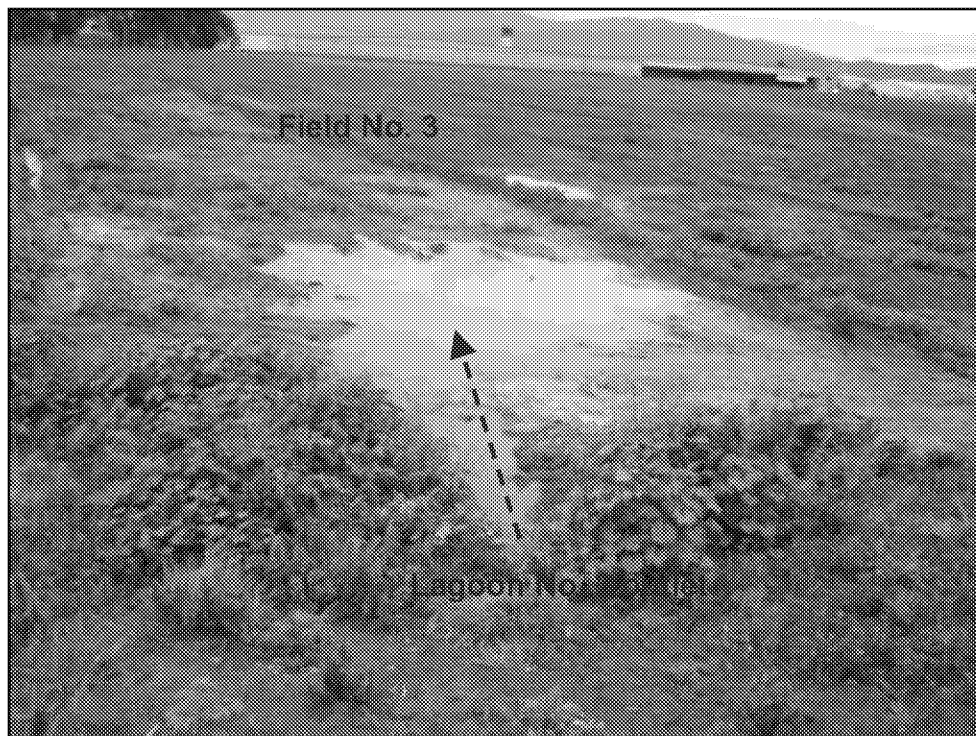
Photograph 12. View facing south of one of the lagoon No. 2 release valve locations on the north side of field No. 3. Note the field was being irrigated with process wastewater at the time of the inspection.

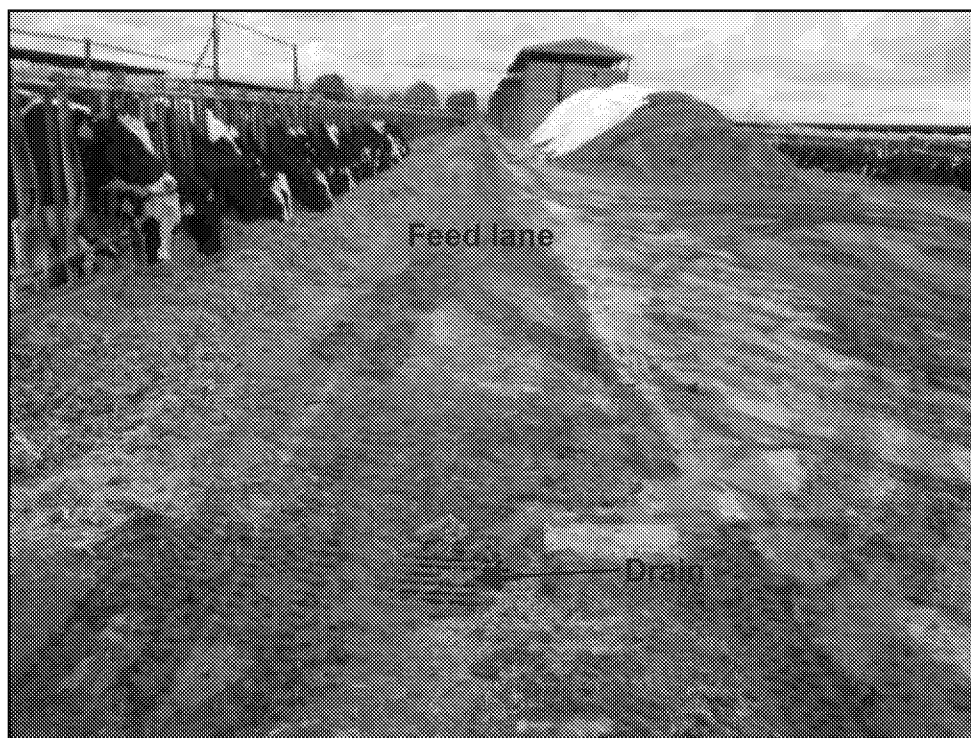
Photograph 13. View facing north of a drain implemented on the south side of the western feed lane. Note the drain is connected to lagoon No. 1.

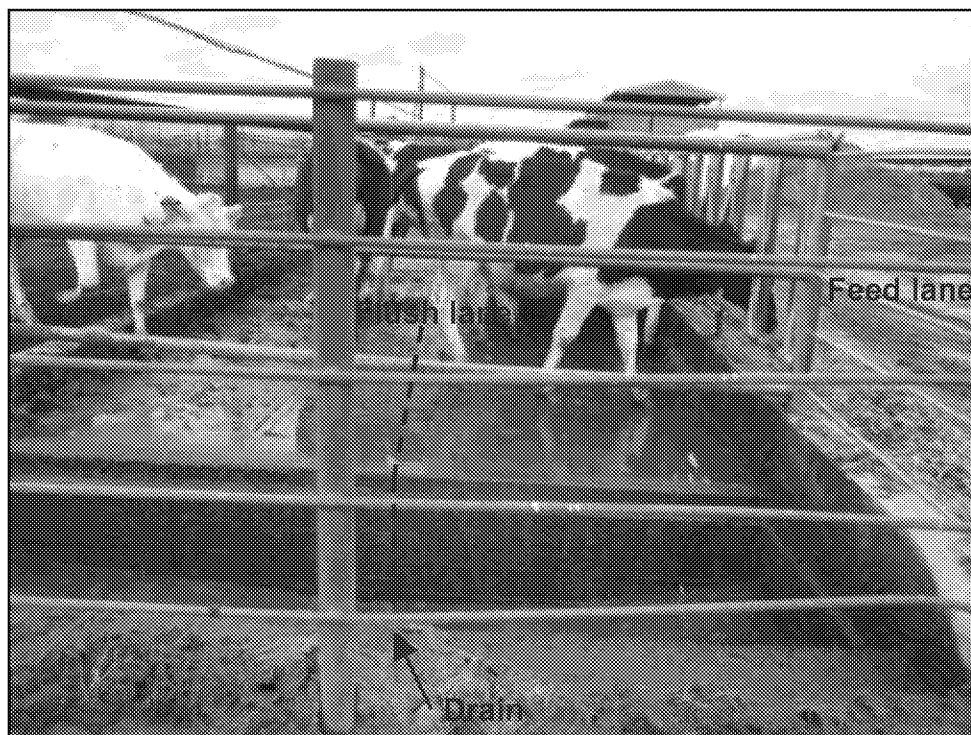
Photograph 14. View facing north of a drain implemented on the south side of the western flush lane. Note the drain is connected to lagoon No. 1, shown in Photograph 4.

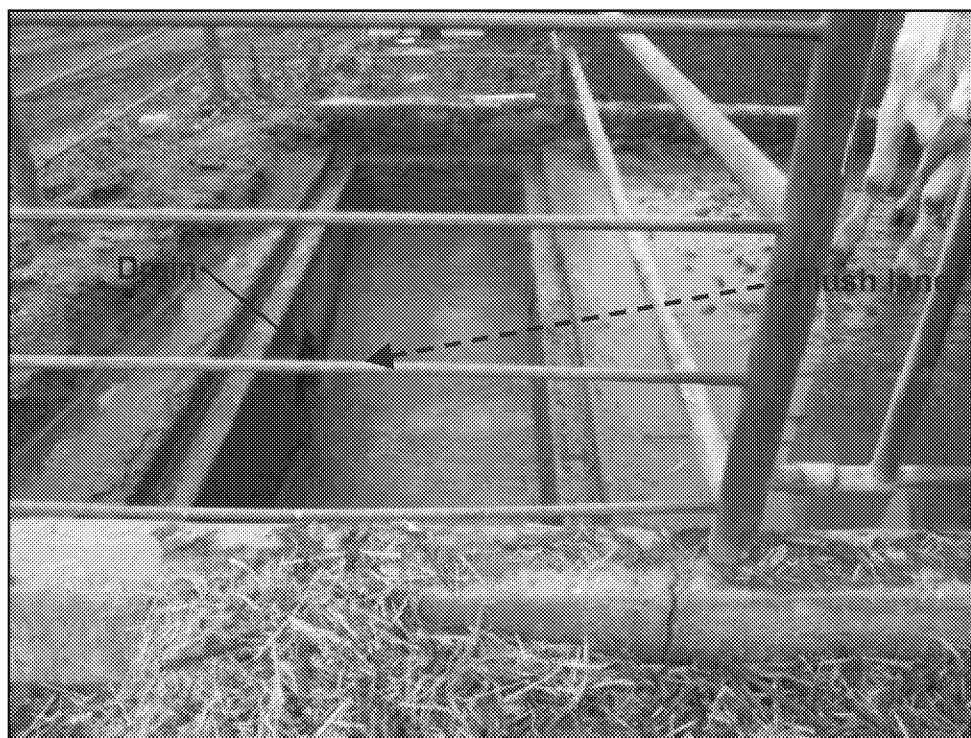
Photograph 15. View facing southwest of a drain implemented on the south side of the western flush lane. Note the drain is connected to lagoon No. 1, shown in Photograph 4.

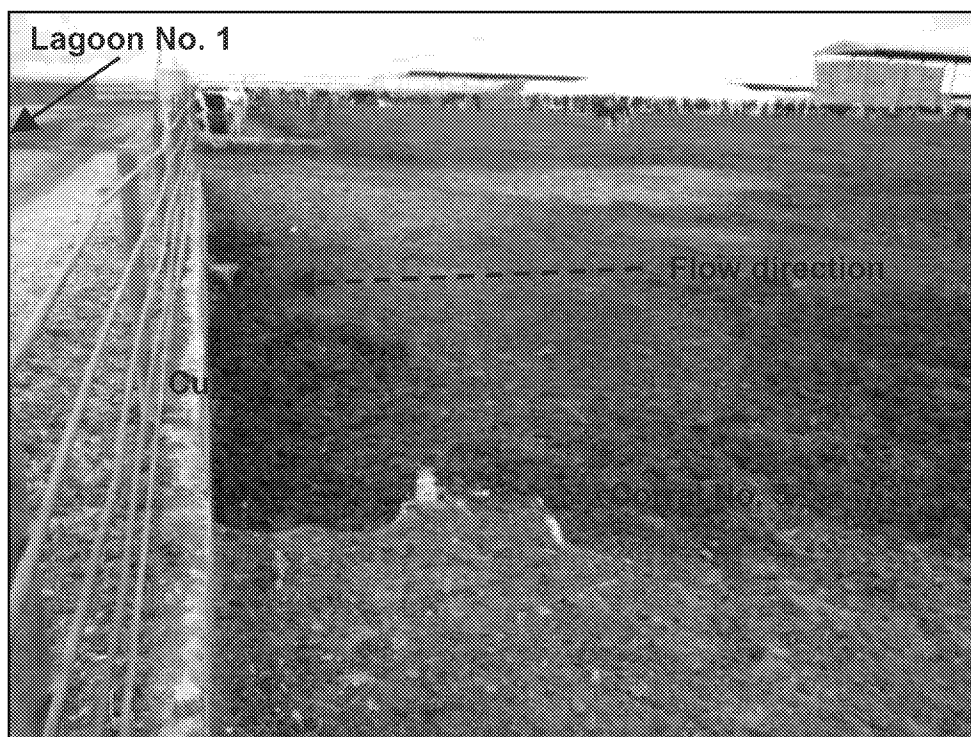
Photograph 16. View facing west of a culvert on the south side of Corral No. 5. Note the culvert conveys storm water runoff from the eastern corrals into lagoon No. 1.

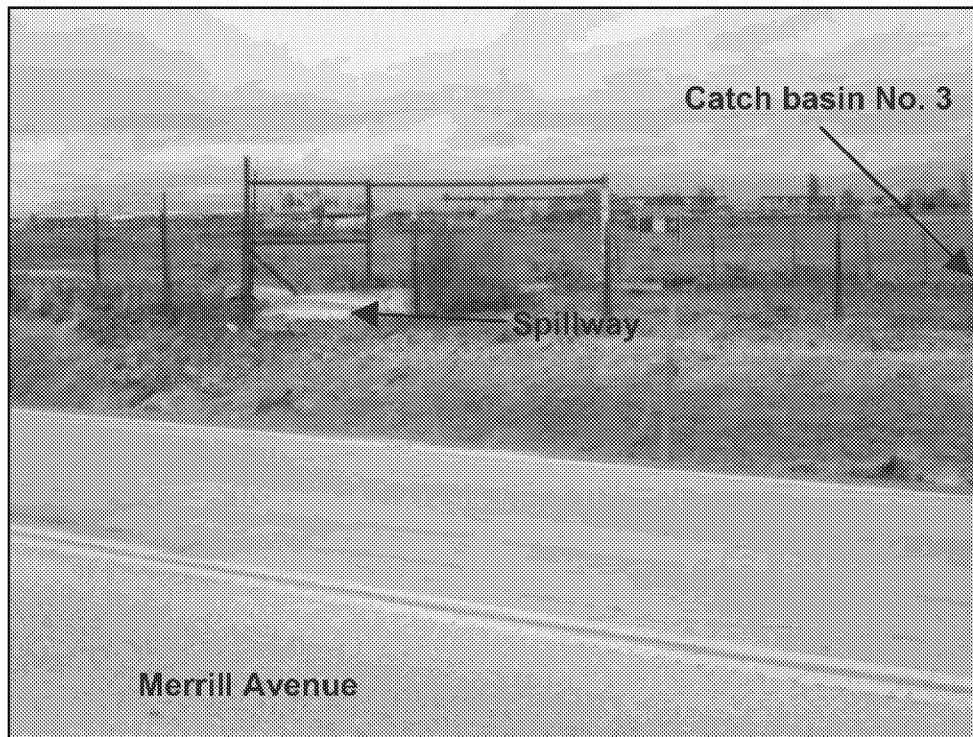
Photograph 17. View facing northwest of the Facility concrete spillway and catch basin No. 3 located in the southwest corner of the Facility, adjacent to Merrill Avenue.
